E. 21st Street MGP Site
E. 14th, E. 17th and E. 19th
Streets MGP Sites
Update

Con Edison
October 3, 2007

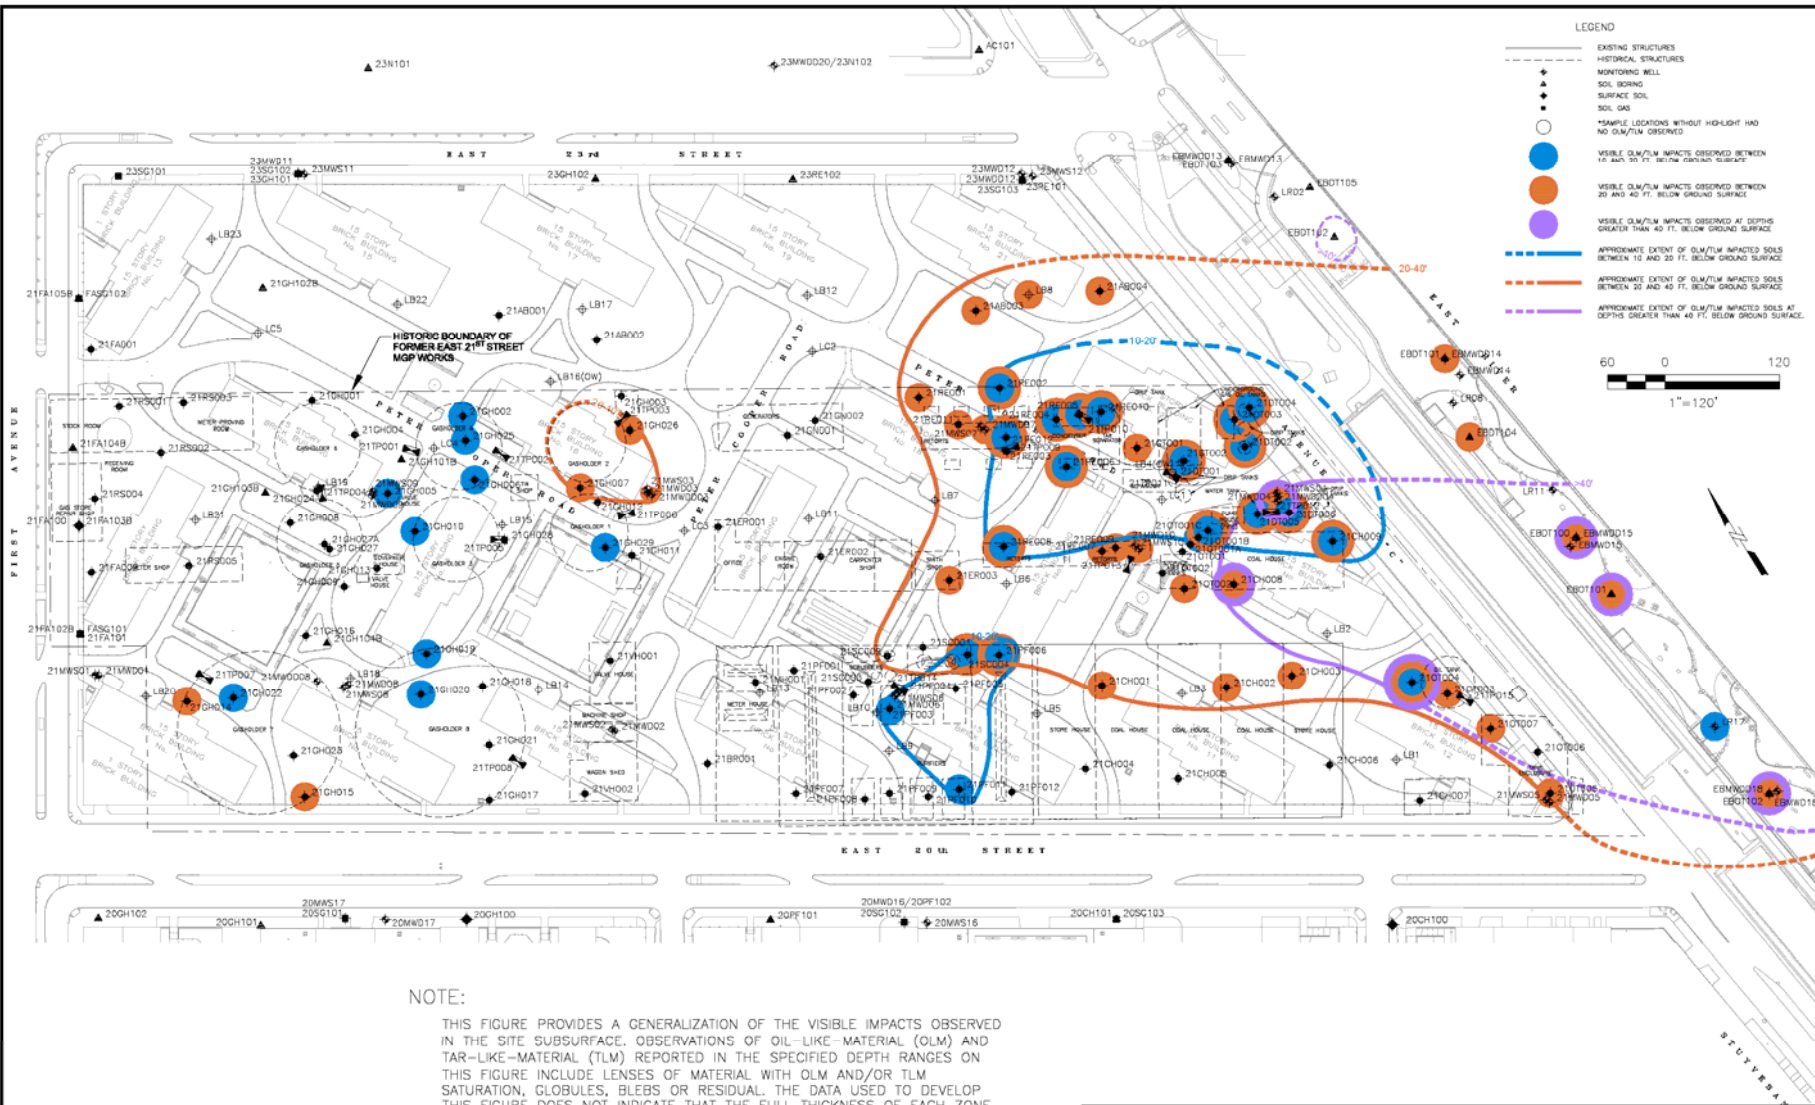
FIGURE 5-8

- No MGP impacts in surface soils
- MGP impacts in subsurface soil is very limited in the first 5 feet (two locations at 2 feet) with most impacts deeper than 10 feet
- Groundwater has MGP impacts but is not used for drinking water
- No impacts in indoor air from MGP

LOWER FILL/NATURAL SOIL AREAS
VISIBLY IMPACTED WITH OLM/TLM
BY DEPTH

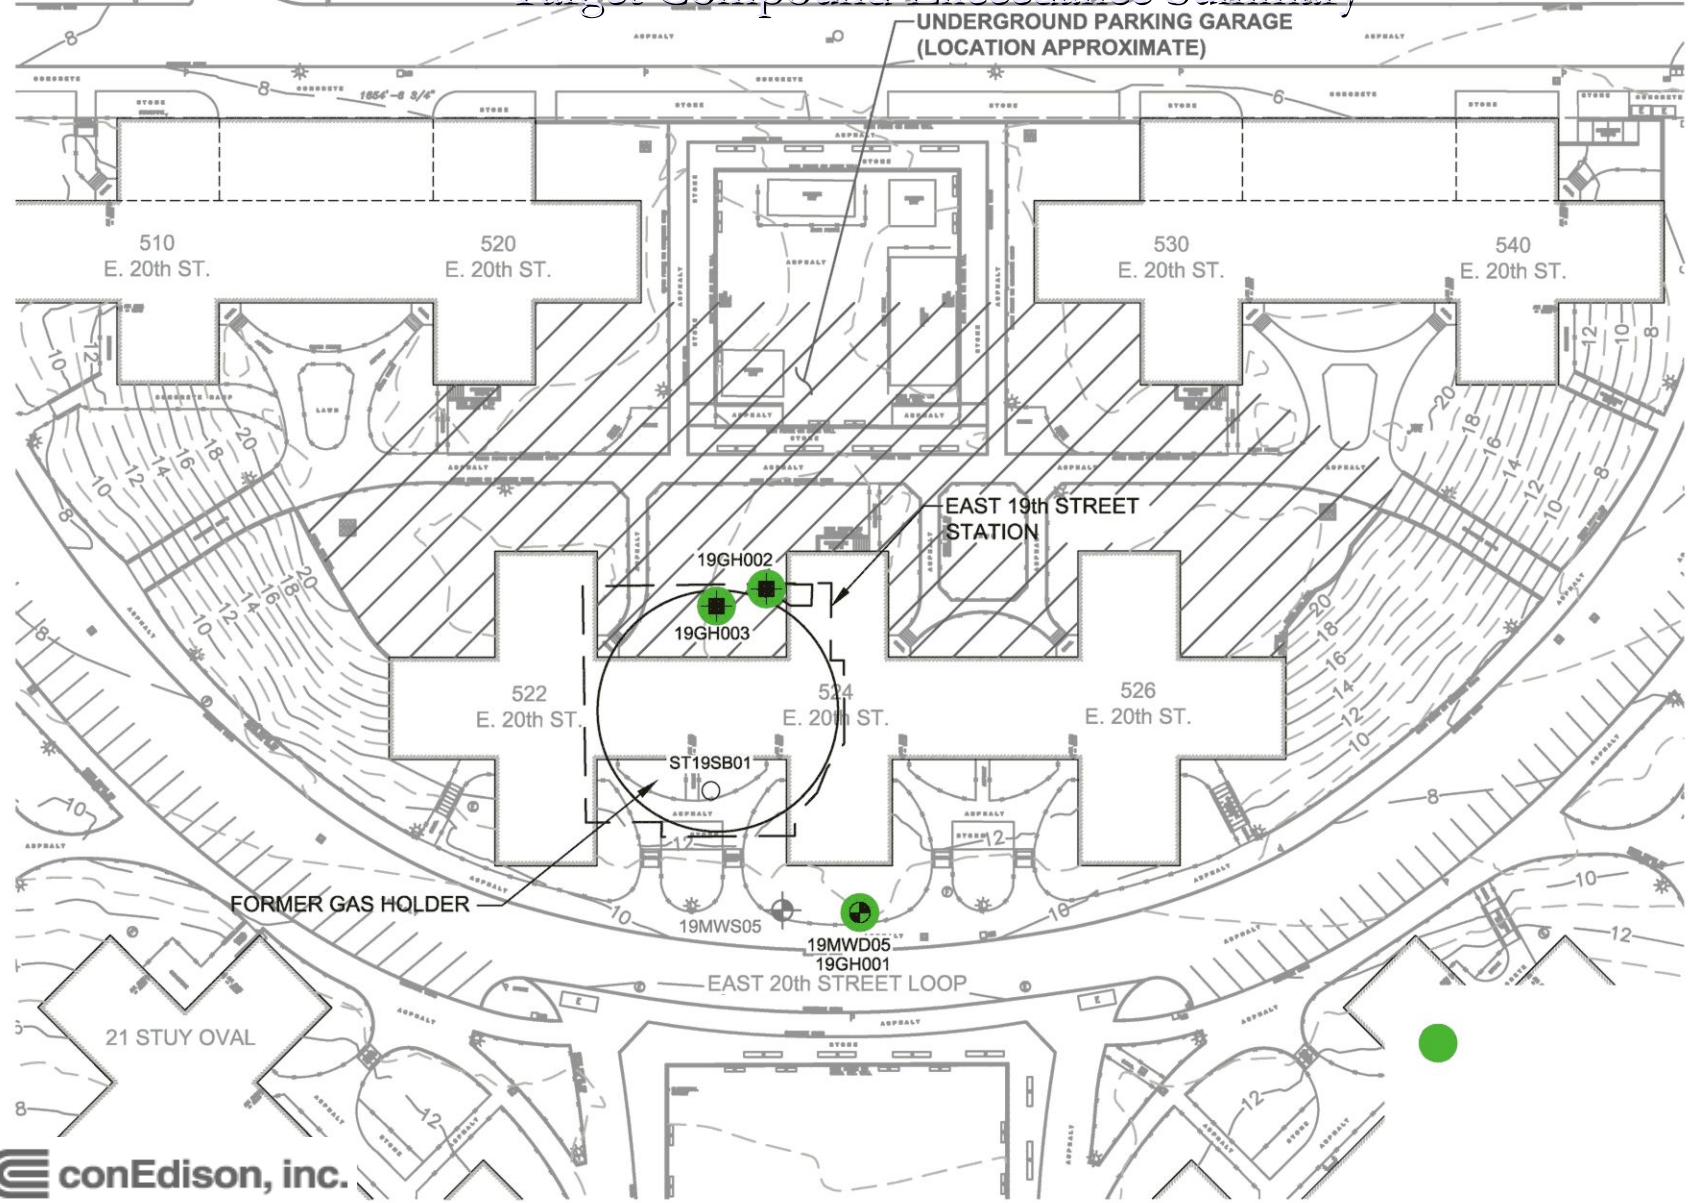
Former East 19th Street Station and E. 20th Street Loop Site Characterization & Remedial Investigation Programs Target Compound Exceedance Summary

- No MGP Impacts in surface soil
- Very limited MGP impacts in subsurface soil starting at 3 feet below ground.
- Minor MGP impacts in groundwater which is not used for drinking water
- No MGP impacts in indoor air
