Final
Remedial Investigation Report
Purdy Street Station

Bronx, New York
VCA Index 02-0003-02-08
Site ID: V00557

Submitted to:
Consolidated Edison Company
of New York, Inc.
31-01 20th Avenue
Astoria, NY 11105

April 8, 2010
032211-2-1102

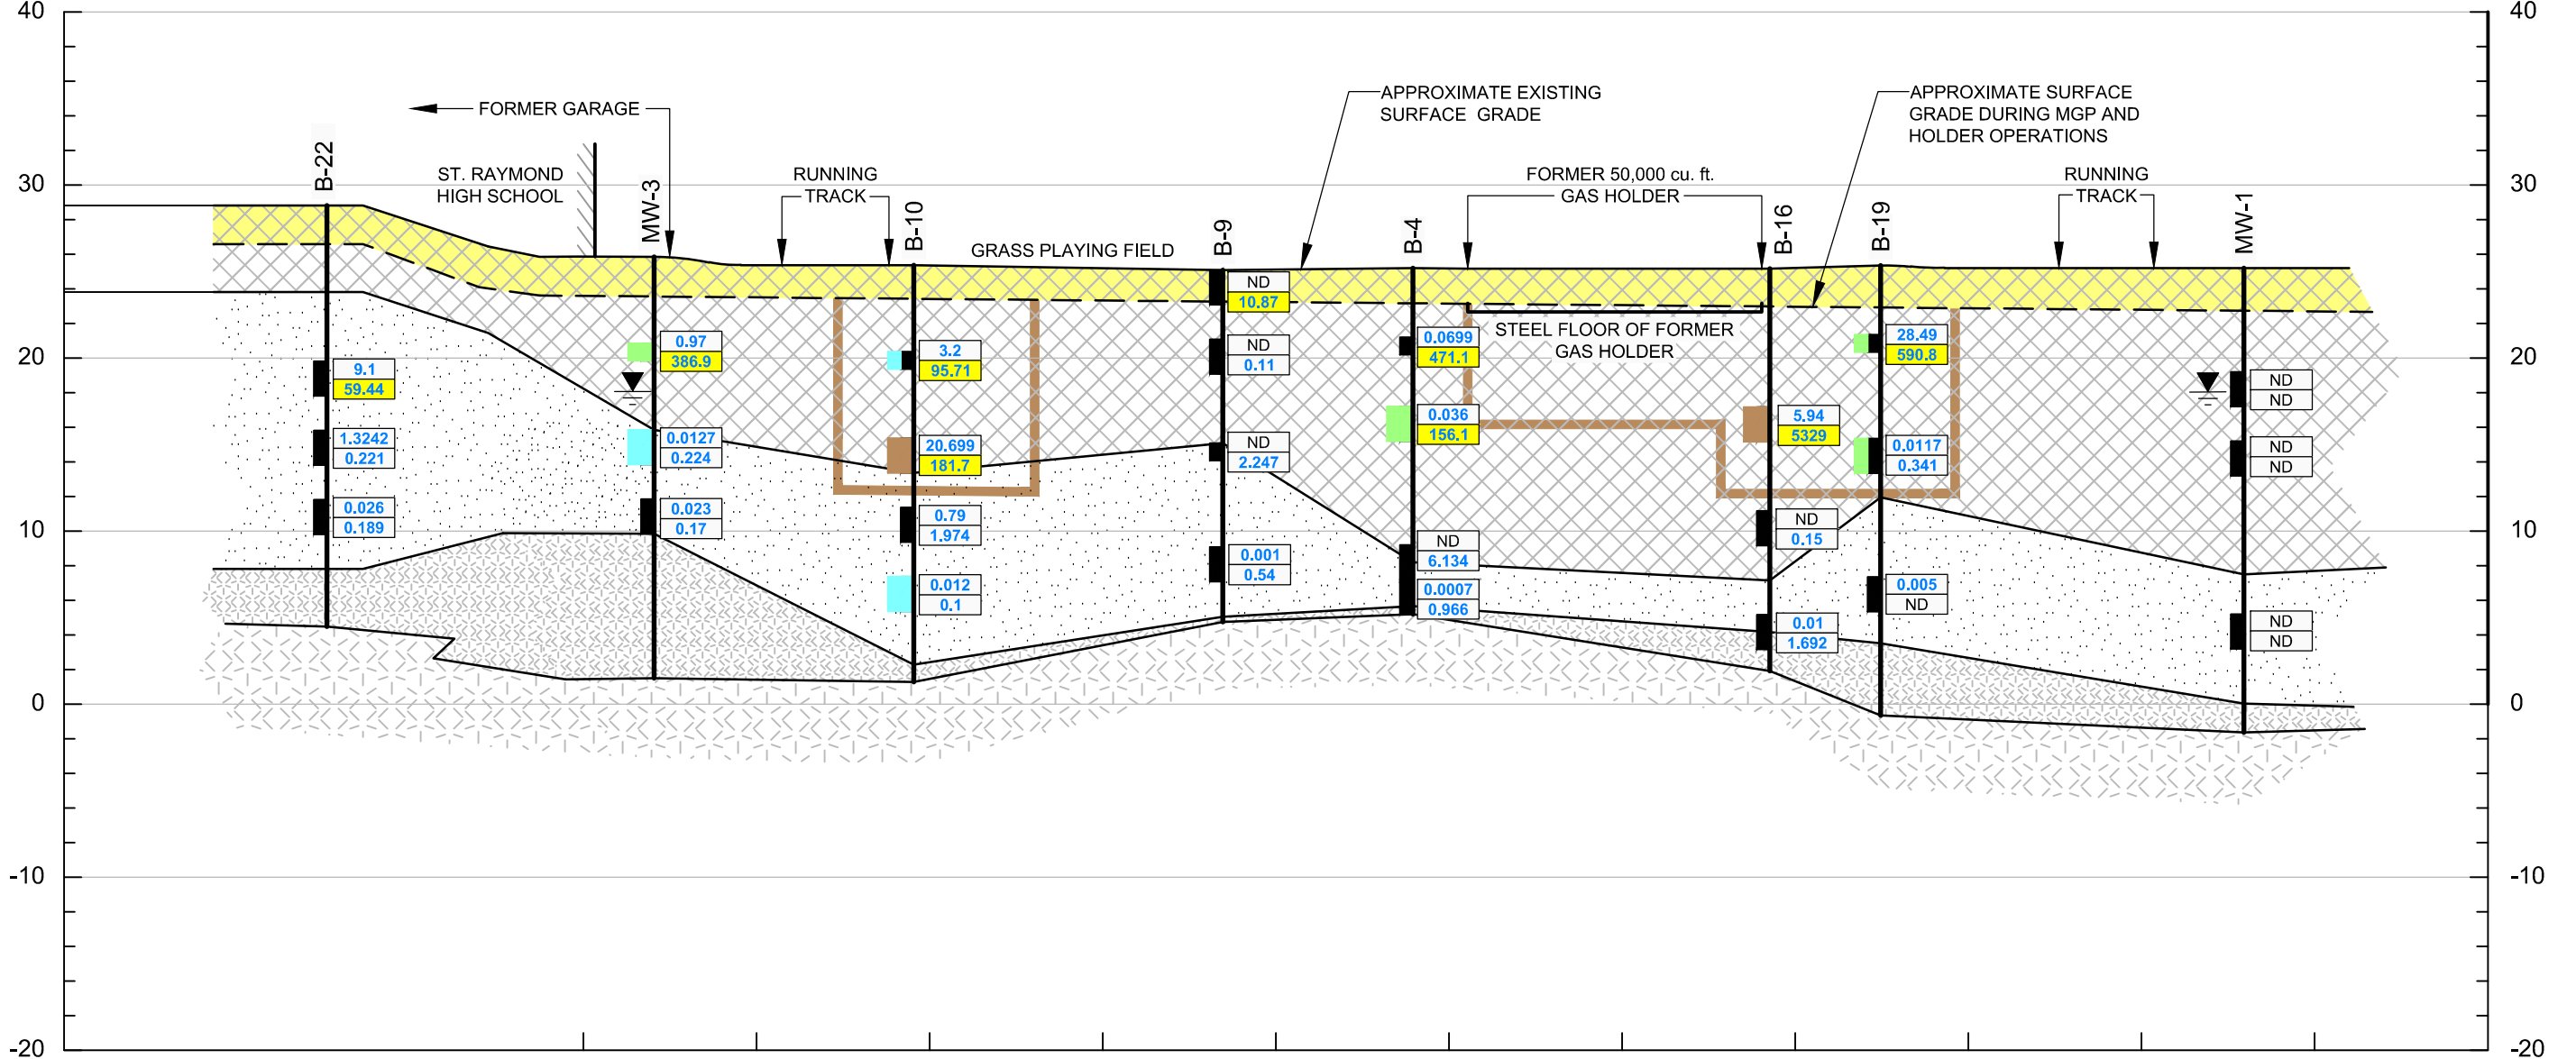
SOUTH
A
ELEV. FT.

NORTH
A'
ELEV. FT.

The borings and test pits that exhibit the MGP-related residues are shown on Figure 12. The test pits and borings located within this area of the site are illustrated on geologic cross-sections (Figures 5 through 8). Analytical samples were collected from each location exhibiting staining, sheens, and/or odors and analyzed for VOCs, SVOCs, TAL metals, PCBs, and cyanide.
