# REMEDIAL INVESTIGATION REPORT

Former West 42nd Street MGP  
VCA Number D2-003-02-08  
Site ID No. V00531

June 2016

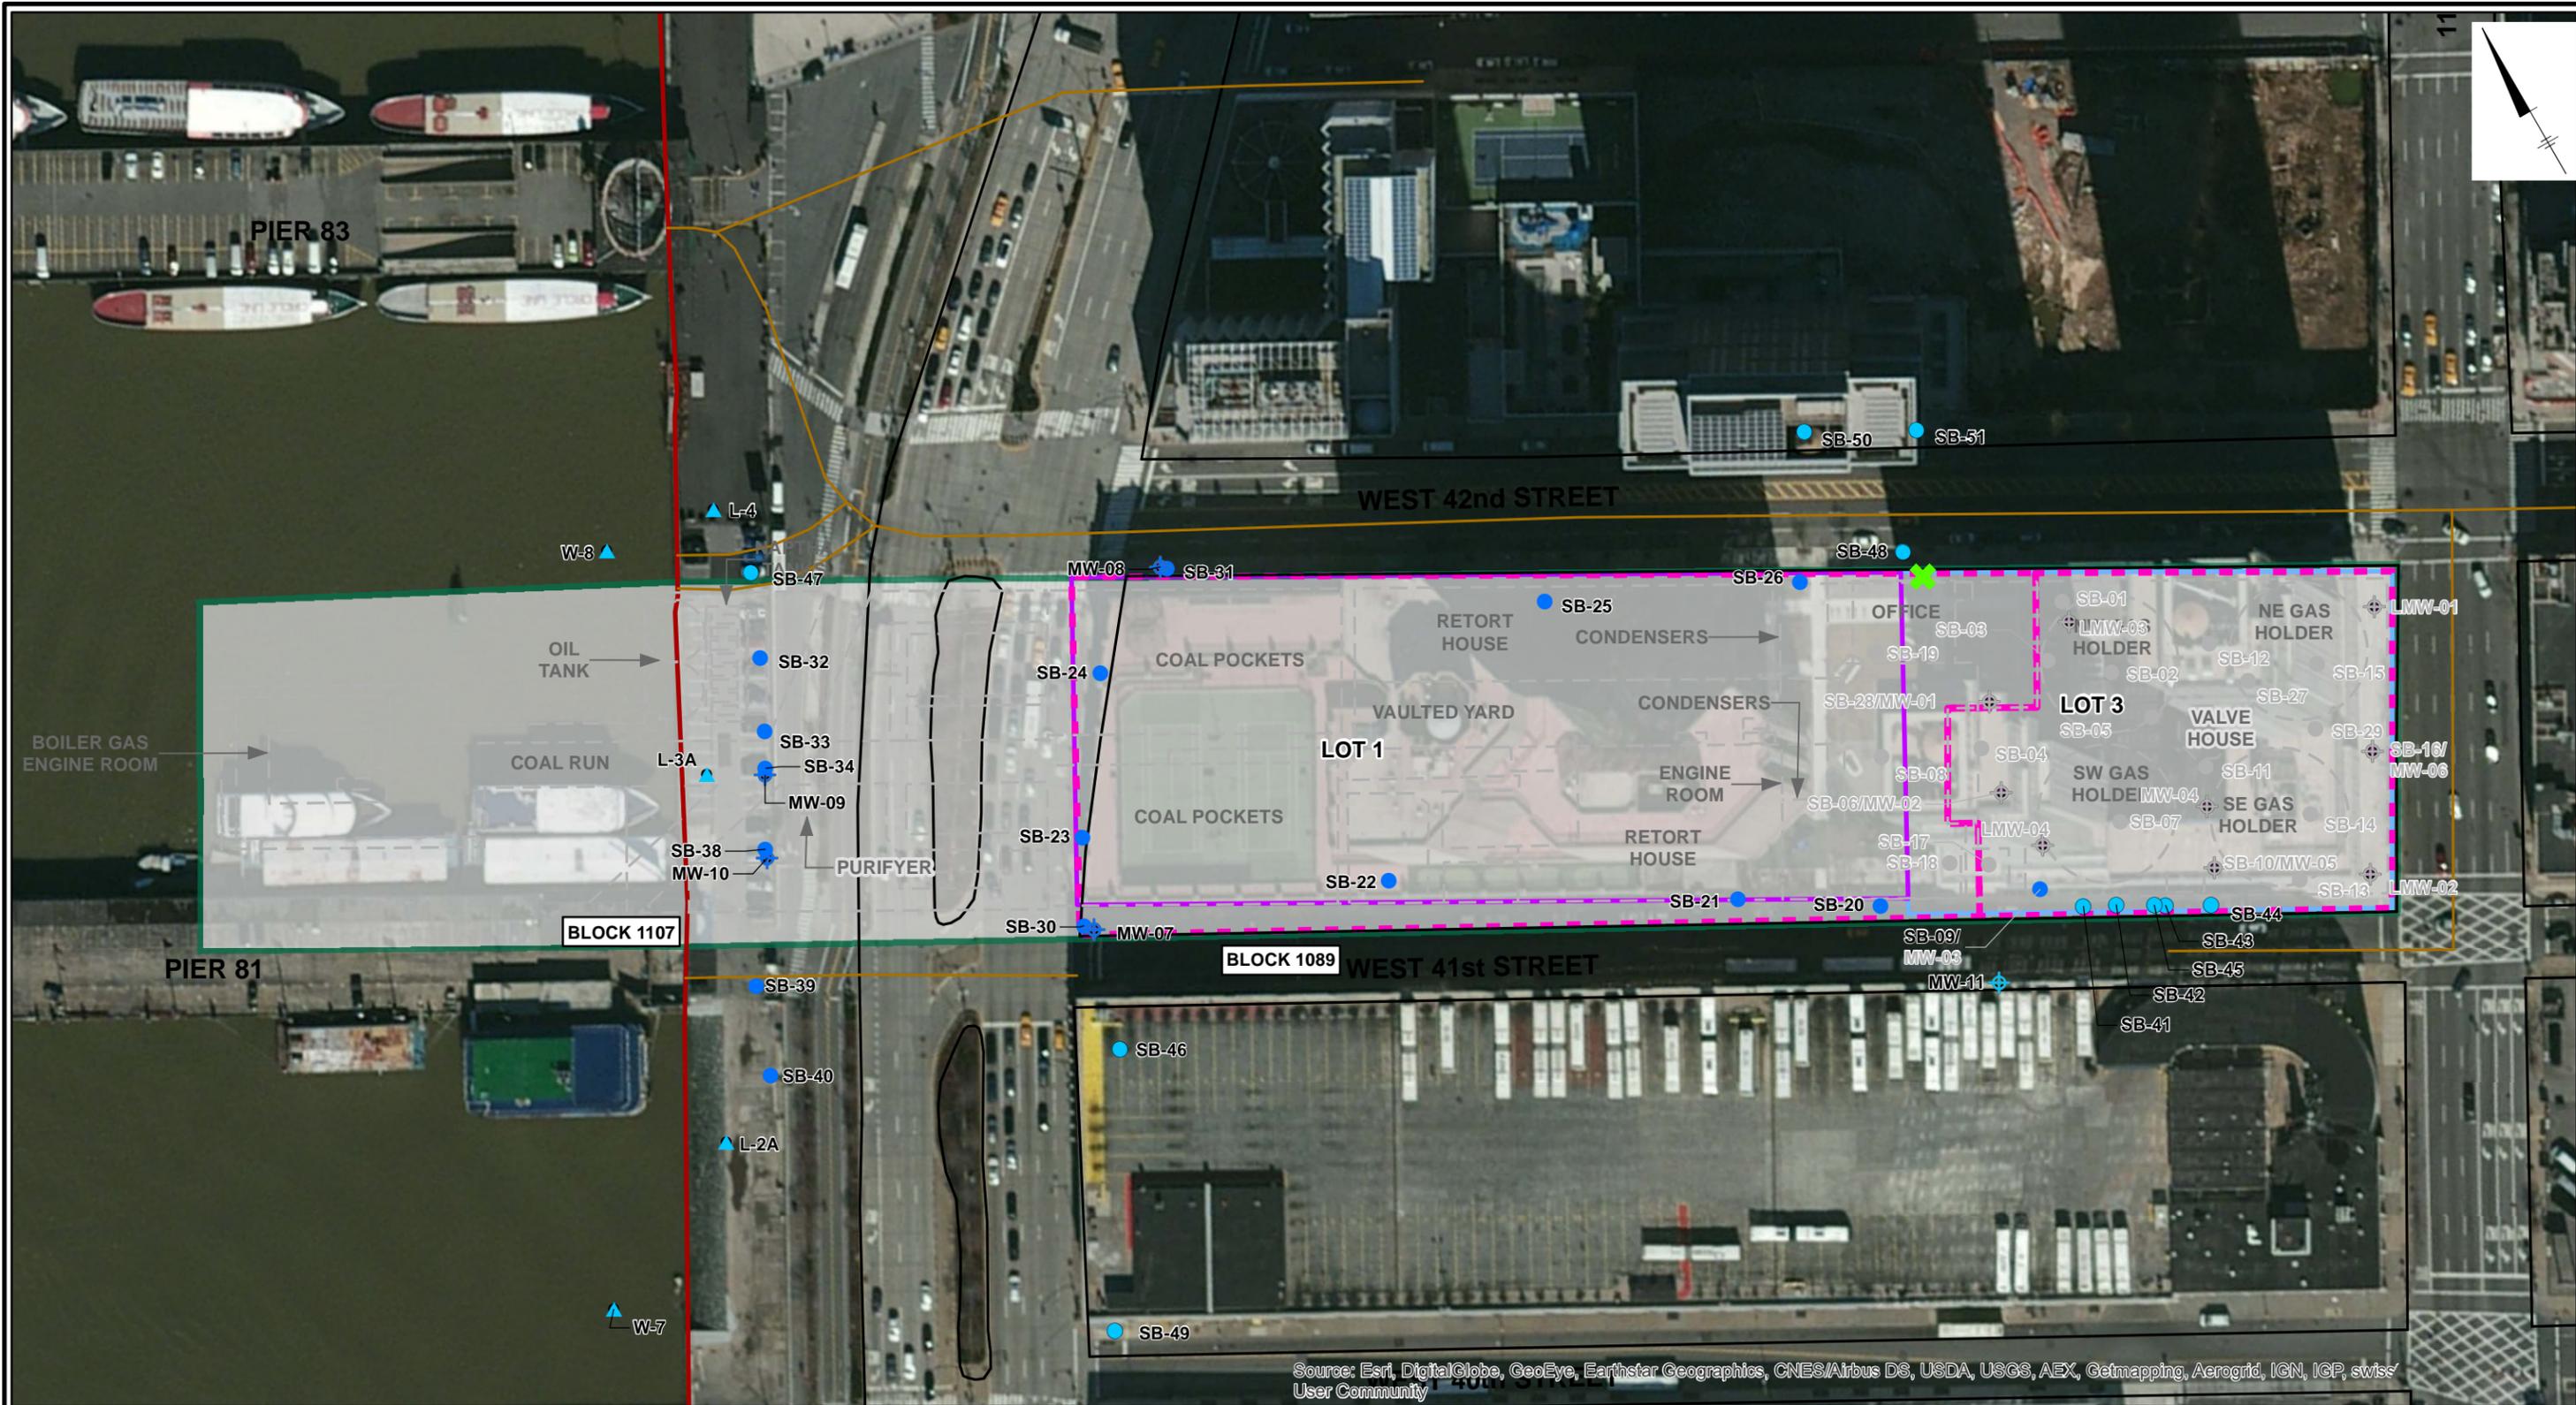
**FIGURE 4-1**

Figure 4-1 presents the locations of soil borings drilled during the supplemental RI. Note that the previous soil borings installed by D&B and during the transformer vault investigation (ARCADIS BBL 2007a) are also shown on Figure 4-1. Data collected and observations made during drilling are presented on boring logs provided in Appendix B of this RI Report. Note that this appendix contains logs for borings drilled both during previous investigations and during the supplemental RI.

One groundwater monitoring well (MW-11) was installed in July 2010 at the site during the supplemental RI to characterize groundwater quality south of MW-3. The previous investigation and supplemental RI monitoring well locations are shown on Figure 4-1. Table 4-5 summarizes the monitoring well construction details for each well installed at the site. Appendix B of this RI Report includes the monitoring well construction logs.

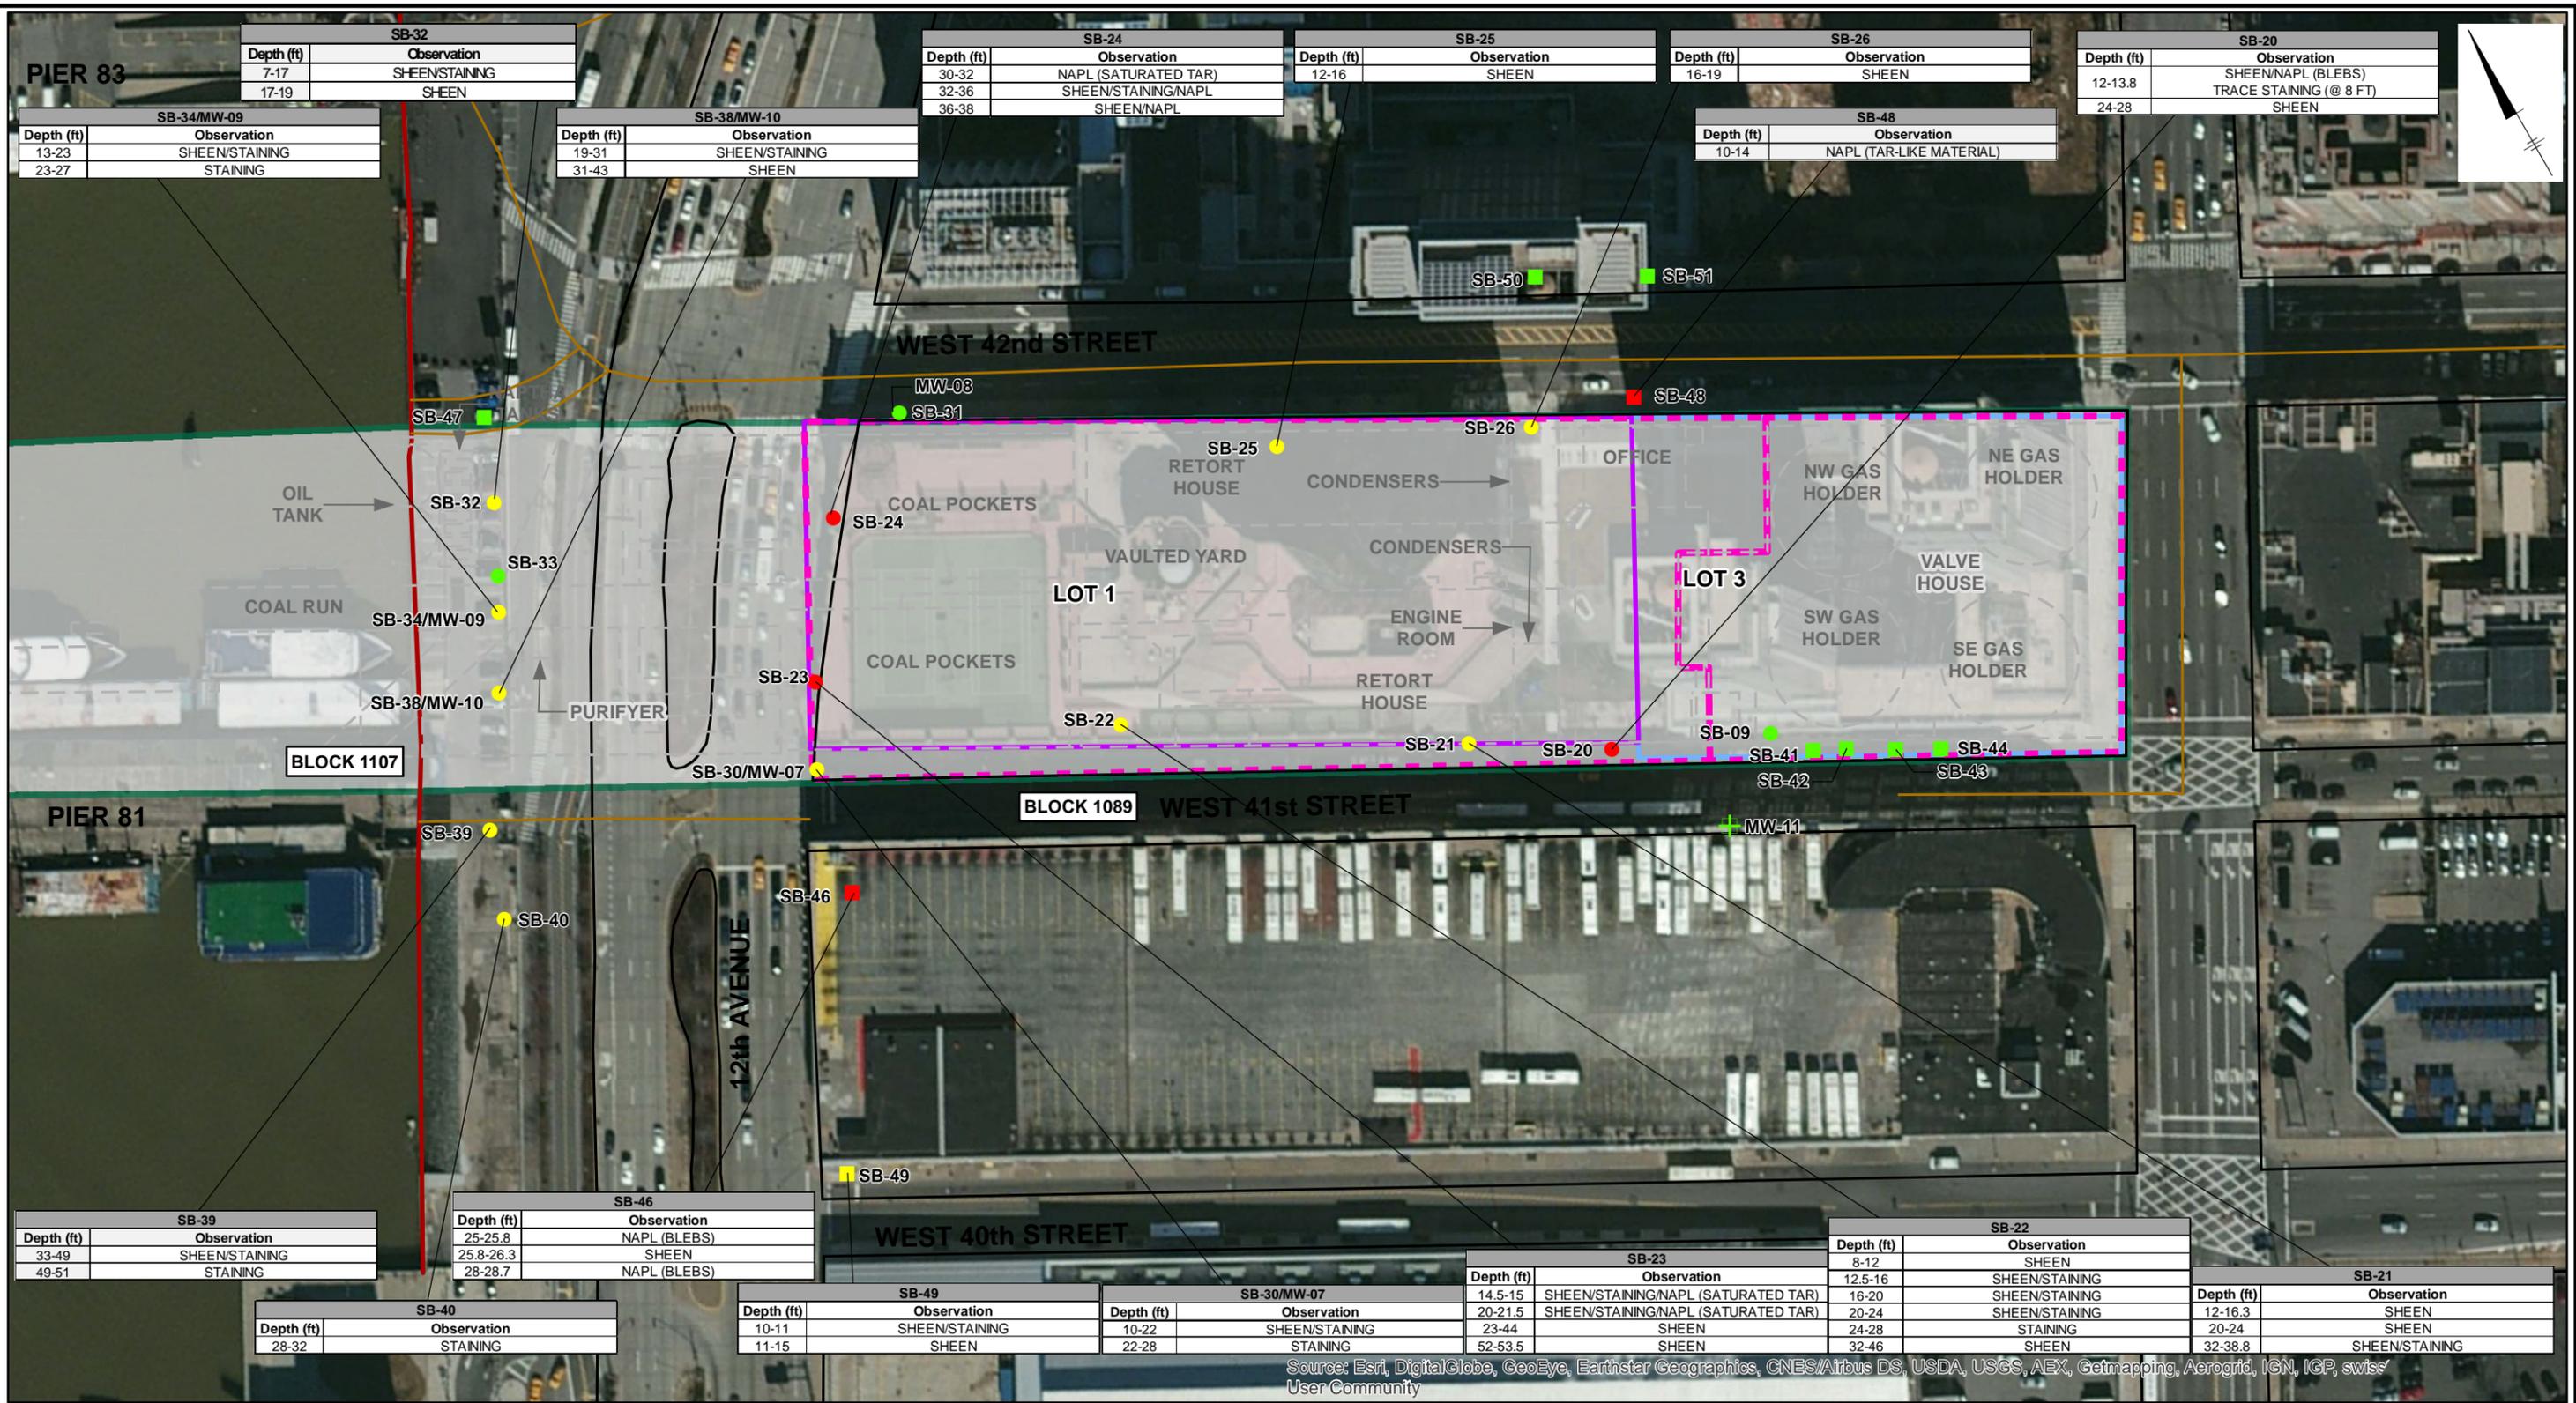
**OCCURRENCE OF NAPL/STAINING/  
 SHEEN IN SOILS**

As depicted on Figure 6-6 and summarized above, no NAPLs or staining were observed along West 42<sup>nd</sup> Street except at boring SB-48, north of the former seepage area along the northern sheeting installed during the remediation at River Place II. However, no visible impacts were observed at the two borings directly north of SB-48 on the northern side of West 42<sup>nd</sup> Street (SB-50 and SB-51). Therefore, the northern extent of NAPL has been delineated. Further, visual/olfactory (beyond slight odors) observations of potential contamination are at and generally deeper than 10 feet.

As depicted on Figure 6-6 and summarized above, no NAPLs, staining, or sheens were observed along West 41<sup>st</sup> Street adjacent to River Place II. Staining and sheens were observed at soil borings SB-20 to SB-22 and SB-30 (discussed below), and trace NAPL blebs were observed in SB-20 along River Place I. No NAPL was observed in the soil boring for MW-11 installed south of SB-20. Therefore, the southern extent of NAPL has been delineated. Further, visual/olfactory (beyond slight odors) observations of potential contamination are at and generally deeper than 8 feet.

SB-32	
Depth (ft)	Observation
7-17	SHEEN/STAINING
17-19	SHEEN

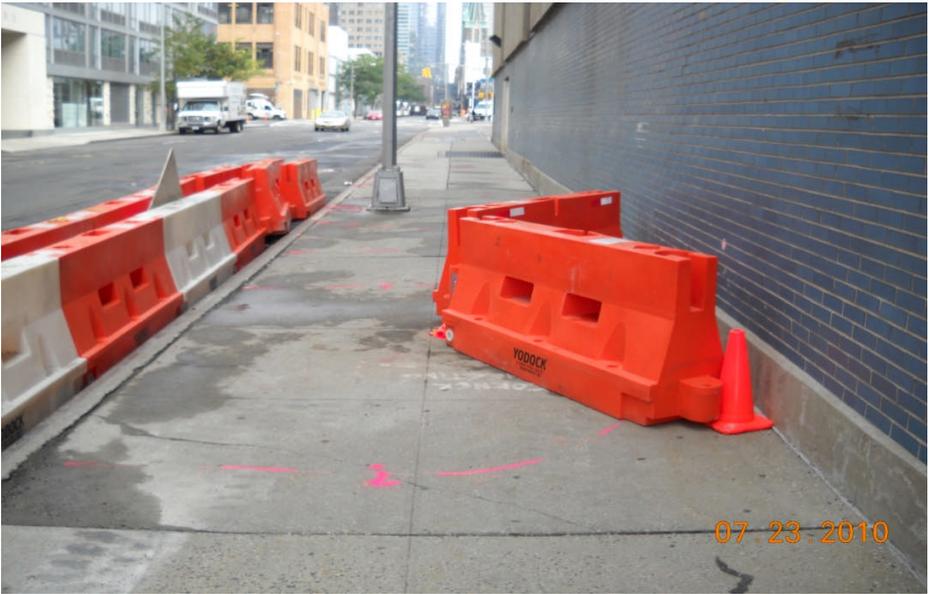
<b>CLIENT:</b> Con Edison	<b>SITE NAME:</b> West 42 <sup>nd</sup> Street Works
<b>PROJECT #:</b> B0043012	<b>SITE LOCATION:</b> West 41 <sup>st</sup> St. Southern sidewalk, Manhattan, New York
<b>PHOTOGRAPH #:</b> 1

<b>PHOTOGRAPHER:</b> PP	
<b>DATE:</b> 07/23/2010	
<b>DIRECTION:</b> East	
<b>COMMENT:</b> Proposed MW-11 location (contained between barriers along the building) with nearby utility mark outs.

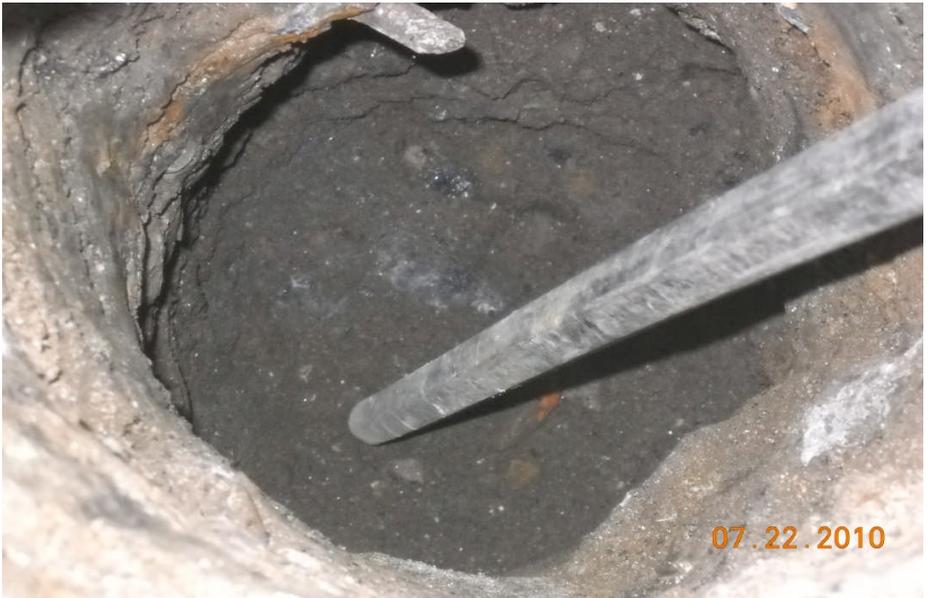
<b>CLIENT:</b> Con Edison	<b>SITE NAME:</b> West 42 <sup>nd</sup> Street Works
<b>PROJECT #:</b> B0043012	<b>SITE LOCATION:</b> West 41 <sup>st</sup> St. Southern sidewalk, Manhattan, New York
<b>PHOTOGRAPH #:</b> 2

<b>PHOTOGRAPHER:</b> PP	
<b>DATE:</b> 07/23/2010	
<b>DIRECTION:</b> N/A	
<b>COMMENT:</b> Completed 5 ft hand clear at MW-11, showing flat Gneiss rock (5"x5.5") at 4.5 feet bgs.

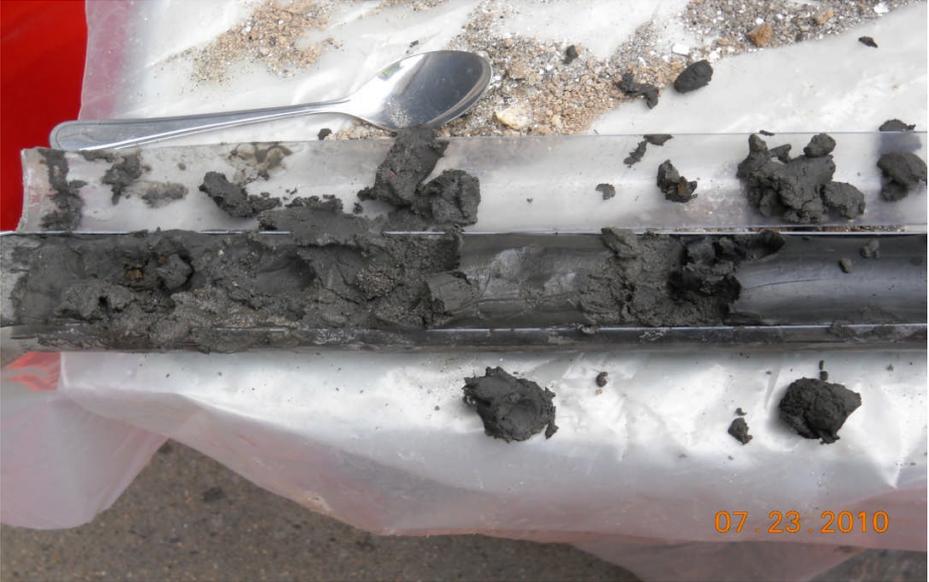
<b>CLIENT:</b> Con Edison	<b>SITE NAME:</b> West 42 <sup>nd</sup> Street Works
<b>PROJECT #:</b> B0043012	<b>SITE LOCATION:</b> West 41 <sup>st</sup> St. Southern sidewalk, Manhattan, New York
<b>PHOTOGRAPH #:</b> 3

<b>PHOTOGRAPHER:</b> PP	
<b>DATE:</b> 07/23/2010	
<b>DIRECTION:</b> N/A	
<b>COMMENT:</b> Soils collected from 15 to 20 feet bgs. Visible impacts were not observed in any of the intervals. PID readings were 0.0.

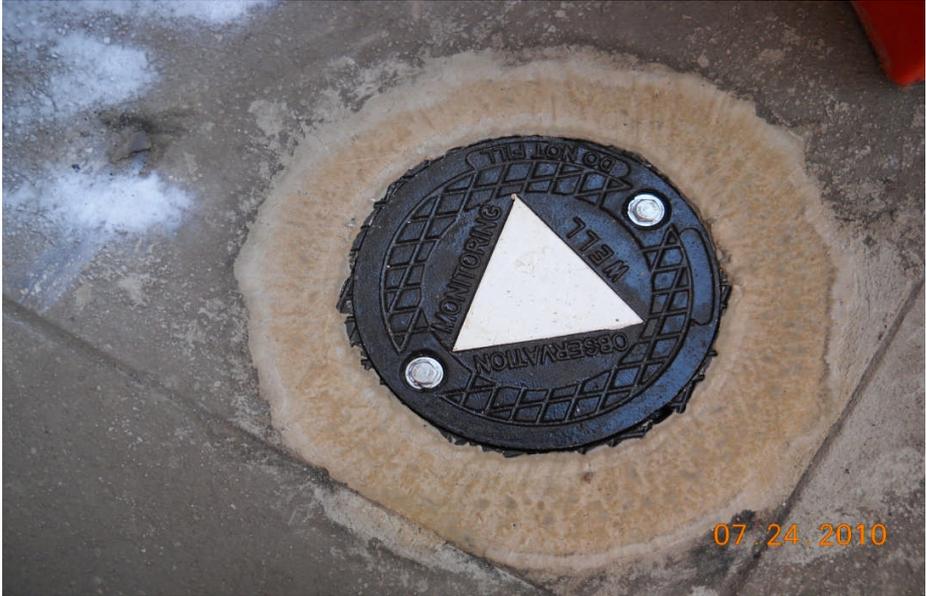
<b>CLIENT:</b> Con Edison	<b>SITE NAME:</b> West 42 <sup>nd</sup> Street Works
<b>PROJECT #:</b> B0043012	<b>SITE LOCATION:</b> West 41 <sup>st</sup> St. Southern sidewalk, Manhattan, New York
<b>PHOTOGRAPH #:</b> 4

<b>PHOTOGRAPHER:</b> PP	
<b>DATE:</b> 07/23/2010	
<b>DIRECTION:</b> West	
<b>COMMENT:</b> Completed MW-11 location, facing West.

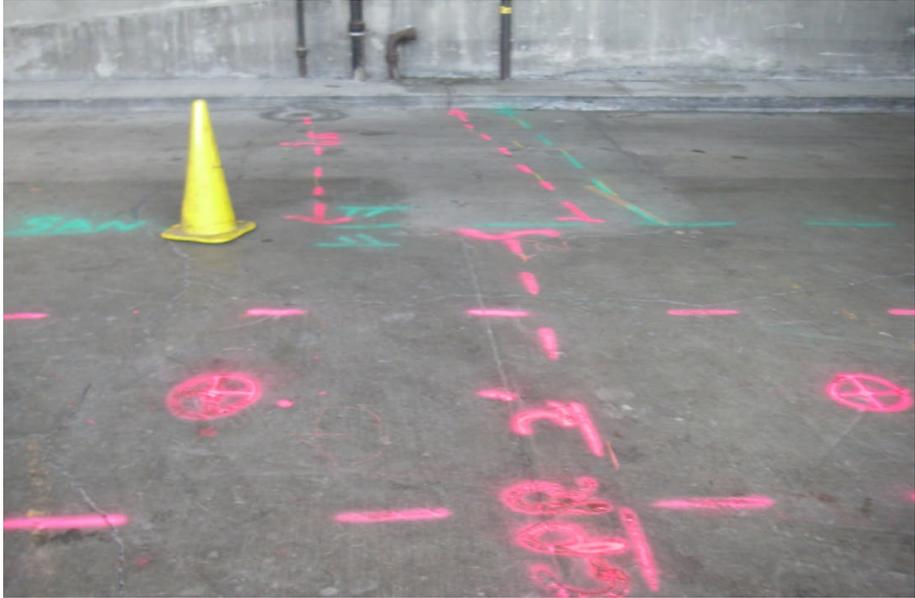
<b>CLIENT:</b> Con Edison	<b>SITE NAME:</b> West 42 <sup>nd</sup> Street Works
<b>PROJECT #:</b> B0043012	<b>SITE LOCATION:</b> (MTA Bus Depot), SE corner 41 <sup>st</sup> & Rt 9A, Manhattan, New York
<b>PHOTOGRAPH #:</b> 1

<b>PHOTOGRAPHER:</b> RA	
<b>DATE:</b> 06/12/2008	
<b>DIRECTION:</b> Southeast	
<b>COMMENT:</b> Proposed SB-46 location (indicated by the pink circles) with nearby utility mark outs.

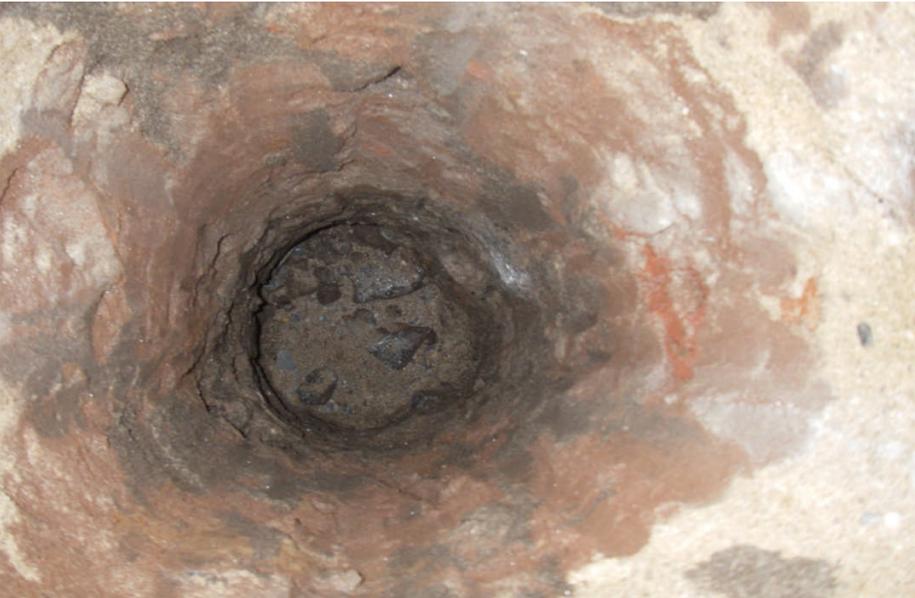
<b>CLIENT:</b> Con Edison	<b>SITE NAME:</b> West 42 <sup>nd</sup> Street Works
<b>PROJECT #:</b> B0043012	<b>SITE LOCATION:</b> (MTA Bus Depot), SE corner 41 <sup>st</sup> & Rt 9A, Manhattan, New York
<b>PHOTOGRAPH #:</b> 2

<b>PHOTOGRAPHER:</b> RA	
<b>DATE:</b> 06/12/2008	
<b>DIRECTION:</b> N/A	
<b>COMMENT:</b> Completed 5 ft hand clear at SB-46, including boulder encountered at approximately 3 – 5 feet bgs.

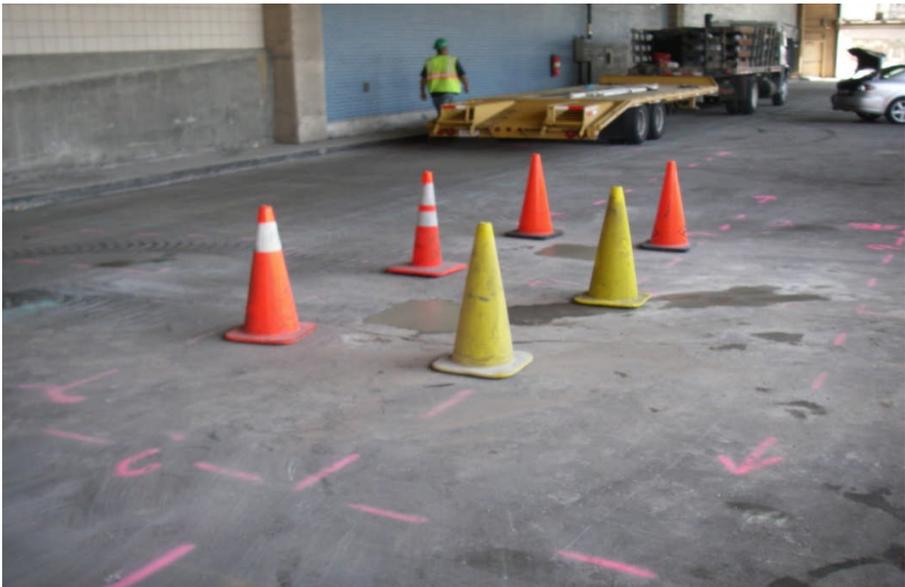
<b>CLIENT:</b> Con Edison	<b>SITE NAME:</b> West 42 <sup>nd</sup> Street Works
<b>PROJECT #:</b> B0043012	<b>SITE LOCATION:</b> (MTA Bus Depot), SE corner 41 <sup>st</sup> & Rt 9A, Manhattan, New York
<b>PHOTOGRAPH #:</b> 4

<b>PHOTOGRAPHER:</b> RA	
<b>DATE:</b> 06/12/2008	
<b>DIRECTION:</b> South	
<b>COMMENT:</b> Completed SB-46 location, facing South.

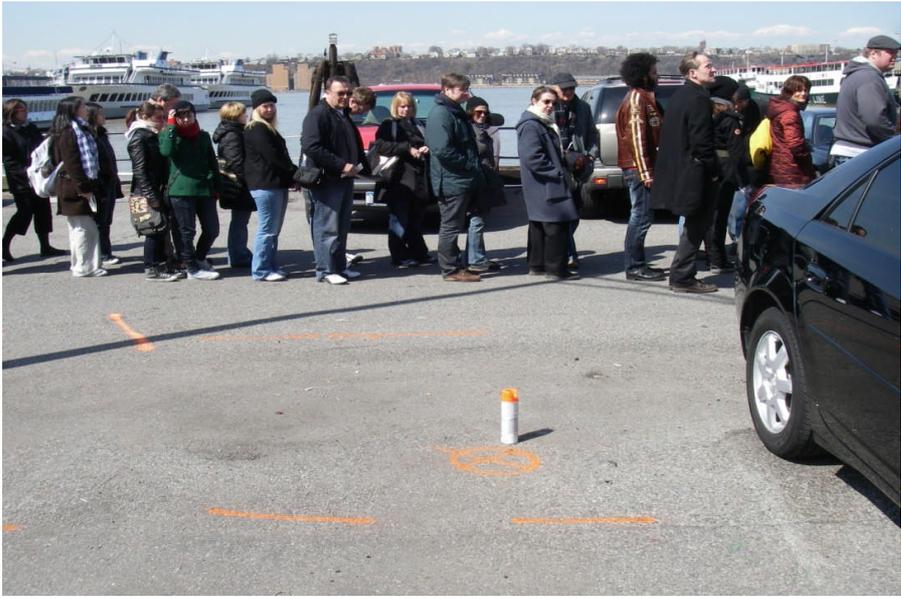
<b>CLIENT:</b> Con Edison	<b>SITE NAME:</b> West 42 <sup>nd</sup> Street Works
<b>PROJECT #:</b> B0043012	<b>SITE LOCATION:</b> (Pier 83), NE corner W 42 <sup>nd</sup> & Rt 9A, Manhattan, New York
<b>PHOTOGRAPH #:</b> 1

<b>PHOTOGRAPHER:</b> CM	
<b>DATE:</b> 03/26/2008	
<b>DIRECTION:</b> Northwest	
<b>COMMENT:</b> Proposed SB-47 location (indicated by the orange circle) with nearby utility mark outs.

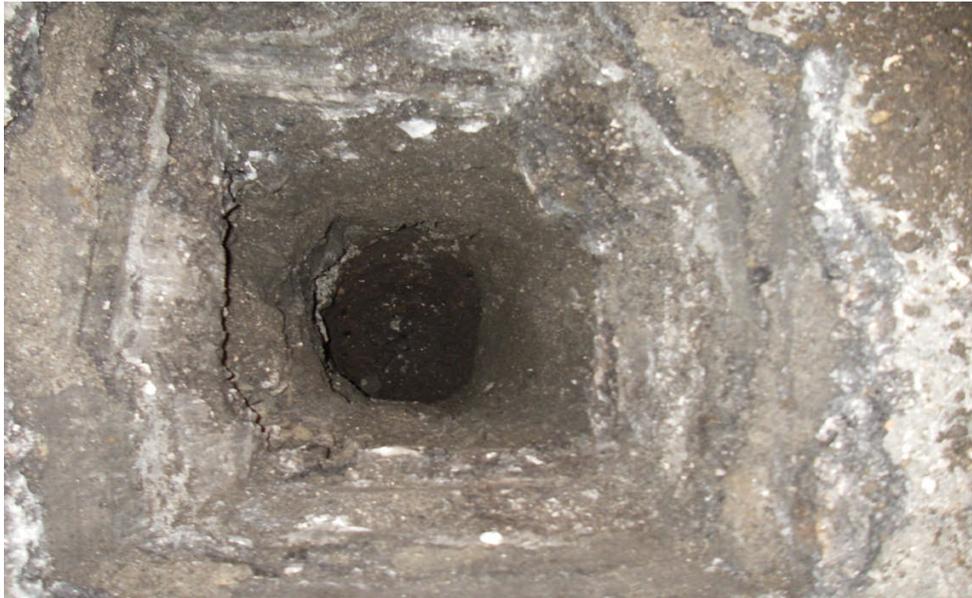
<b>PHOTOGRAPHER:</b> CM	
<b>DATE:</b> 03/26/2008	
<b>DIRECTION:</b> N/A	
<b>COMMENT:</b> Completed 5 ft hand clear at SB-47, including asphalt, sand, brick, and rock fragments.

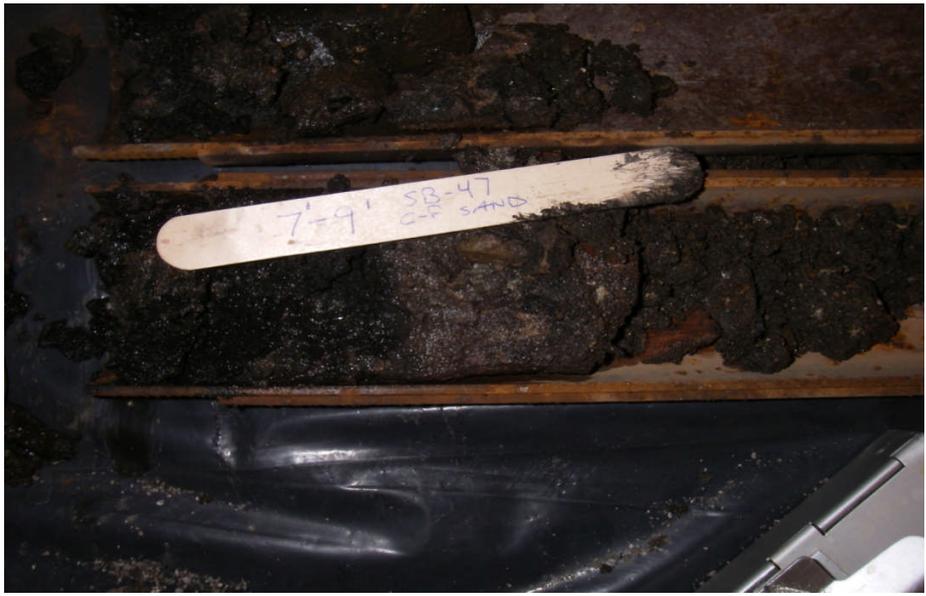
<b>PHOTOGRAPHER:</b> CM	
<b>DATE:</b> 03/26/2008	
<b>DIRECTION:</b> N/A	
<b>COMMENT:</b> Soils collected from 7 to 9 feet bgs. No visual impacts were identified throughout boring.

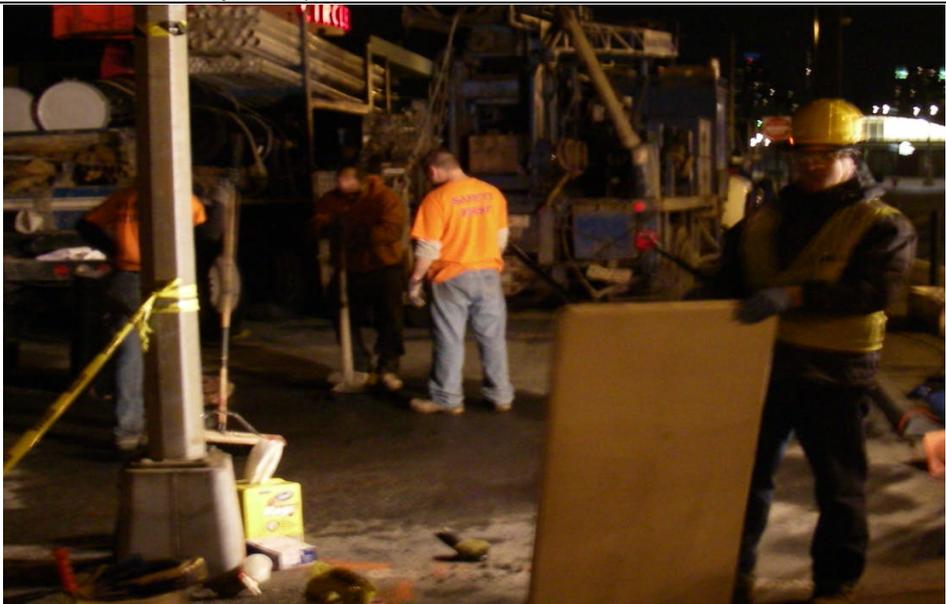
<b>CLIENT:</b> Con Edison	<b>SITE NAME:</b> West 42 <sup>nd</sup> Street Works
<b>PROJECT #:</b> B0043012	<b>SITE LOCATION:</b> (Pier 83), NE corner W 42 <sup>nd</sup> & Rt 9A, Manhattan, New York
<b>PHOTOGRAPH #:</b> 4

<b>PHOTOGRAPHER:</b> CM	
<b>DATE:</b> 03/26/2008	
<b>DIRECTION:</b> Northeast	
<b>COMMENT:</b> Completed SB-47 location, facing Northeast.

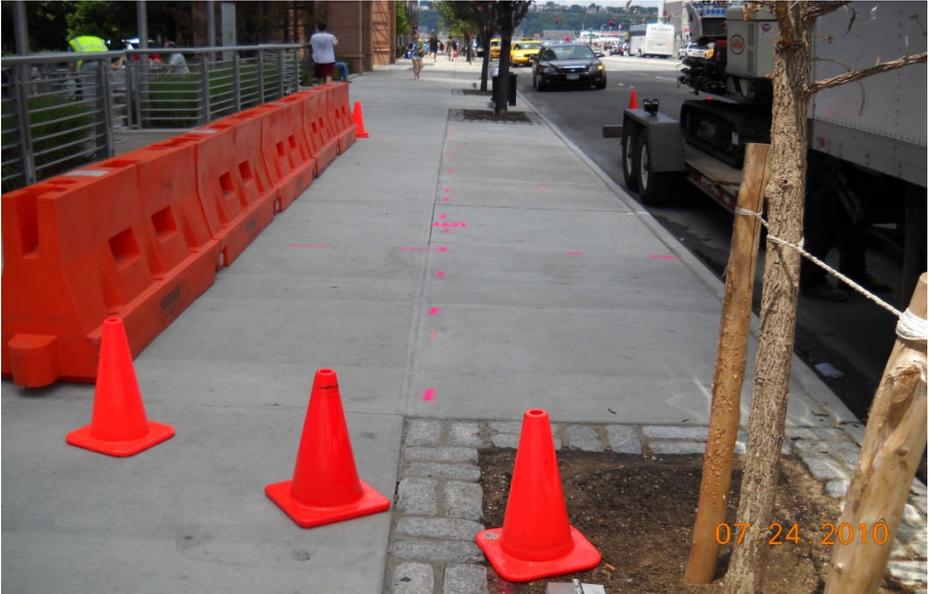
<b>CLIENT:</b> Con Edison	<b>SITE NAME:</b> West 42 <sup>nd</sup> Street Works
<b>PROJECT #:</b> B0043012	<b>SITE LOCATION:</b> 620 W 42 <sup>nd</sup> St. Sidewalk, Manhattan, New York
<b>PHOTOGRAPH #:</b> 1

<b>PHOTOGRAPHER:</b> PP	
<b>DATE:</b> 07/24/2010	
<b>DIRECTION:</b> Northwest	
<b>COMMENT:</b> Proposed SB-48 location (midpoint of orange barriers) with nearby utility mark outs.

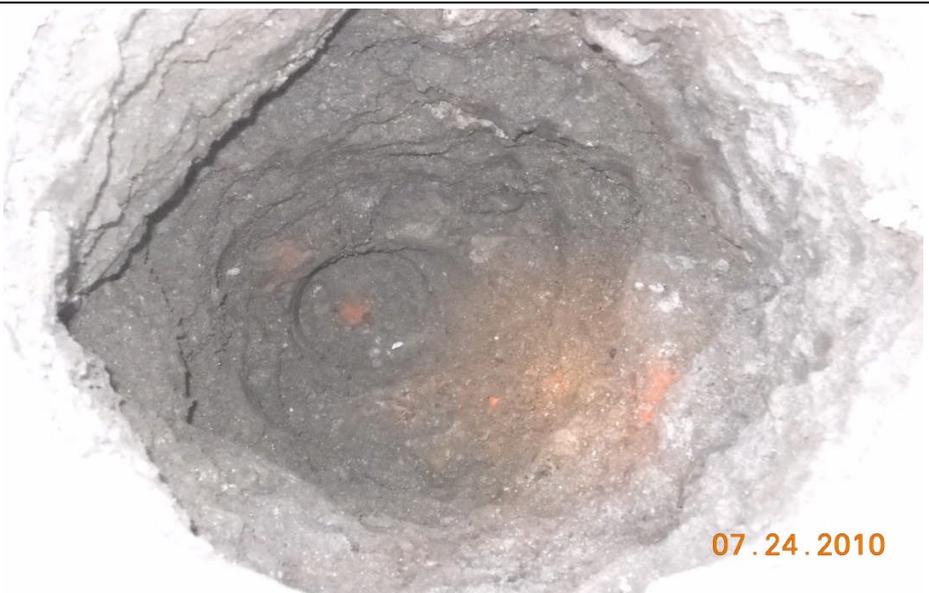
<b>CLIENT:</b> Con Edison	<b>SITE NAME:</b> West 42 <sup>nd</sup> Street Works
<b>PROJECT #:</b> B0043012	<b>SITE LOCATION:</b> 620 W 42 <sup>nd</sup> St. Sidewalk, Manhattan, New York
<b>PHOTOGRAPH #:</b> 2

<b>PHOTOGRAPHER:</b> PP	
<b>DATE:</b> 07/24/2010	
<b>DIRECTION:</b> N/A	
<b>COMMENT:</b> Completed 5 ft hand clear at SB-48.

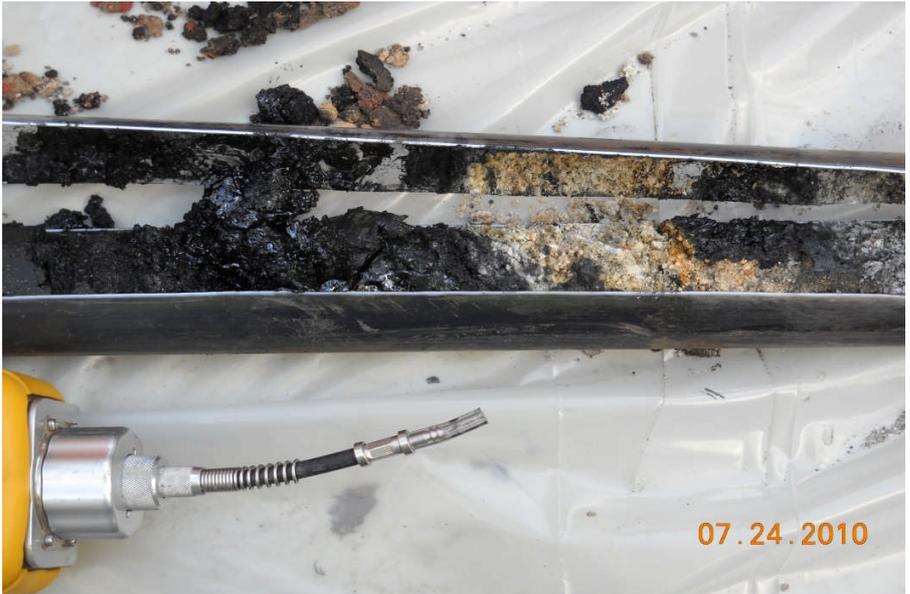
<b>PHOTOGRAPHER:</b> PP	
<b>DATE:</b> 07/24/2010	
<b>DIRECTION:</b> N/A	
<b>COMMENT:</b> Soils collected from 10 - 15 feet bgs. Note that the collected soils contained visible tar-like material and a moderate odor (PID readings ranged 60 - 537 ppm in this interval).

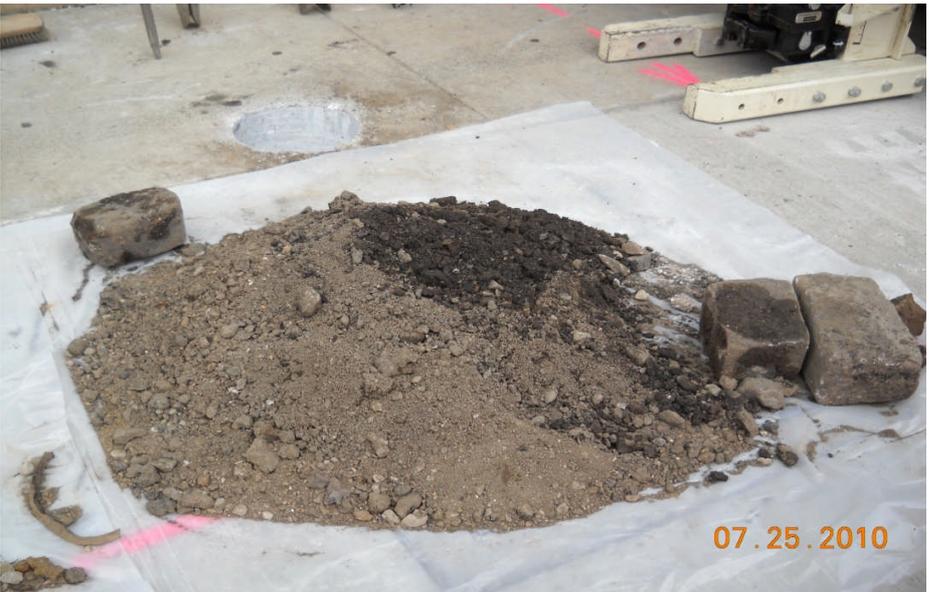
<b>PHOTOGRAPHER:</b> PP	
<b>DATE:</b> 07/25/2010	
<b>DIRECTION:</b> North	
<b>COMMENT:</b> Completed 5 ft hand clear at SB-49, soils removed included heavy red pavers encountered at approximately 3.15 – 4 feet bgs.

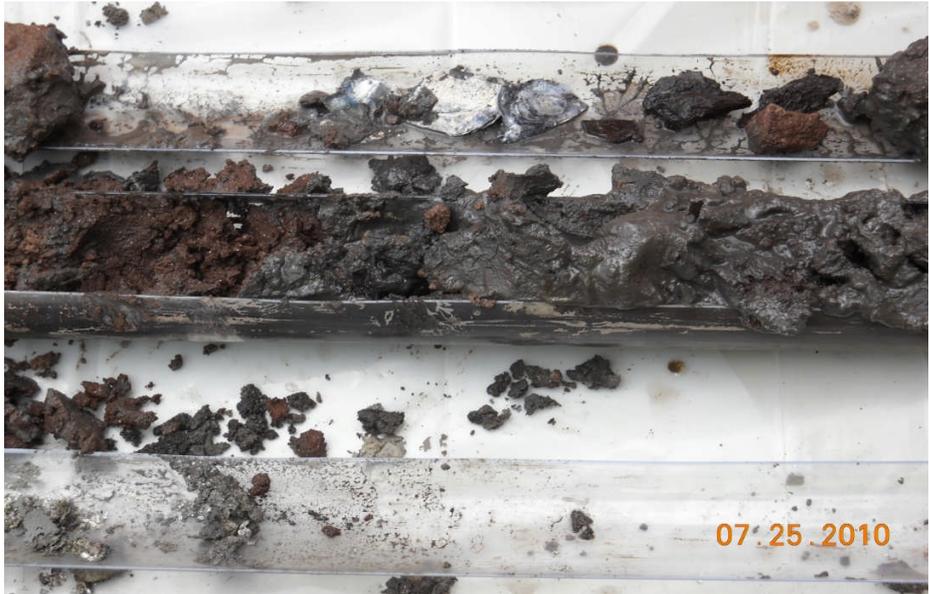
<b>PHOTOGRAPHER:</b> PP	
<b>DATE:</b> 07/25/2010	
<b>DIRECTION:</b> N/A	
<b>COMMENT:</b> Soils collected from 10 to 15 feet bgs. The sample exhibited an iridescent sheen and a moderate odor (PID readings ranged from 11.25 - 47 ppm in this interval).

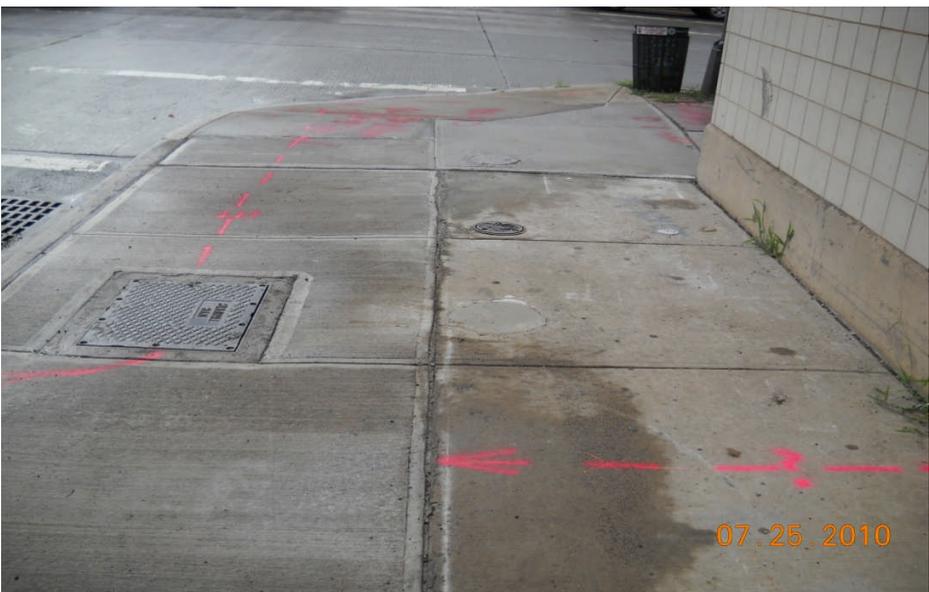
<b>CLIENT:</b> Con Edison	<b>SITE NAME:</b> West 42 <sup>nd</sup> Street Works
<b>PROJECT #:</b> B0043012	<b>SITE LOCATION:</b> West 40 <sup>th</sup> St. Northern sidewalk, Manhattan, New York
<b>PHOTOGRAPH #:</b> 4

<b>PHOTOGRAPHER:</b> PP	
<b>DATE:</b> 07/25/2010	
<b>DIRECTION:</b> West	
<b>COMMENT:</b> Completed SB-49 location, facing West.

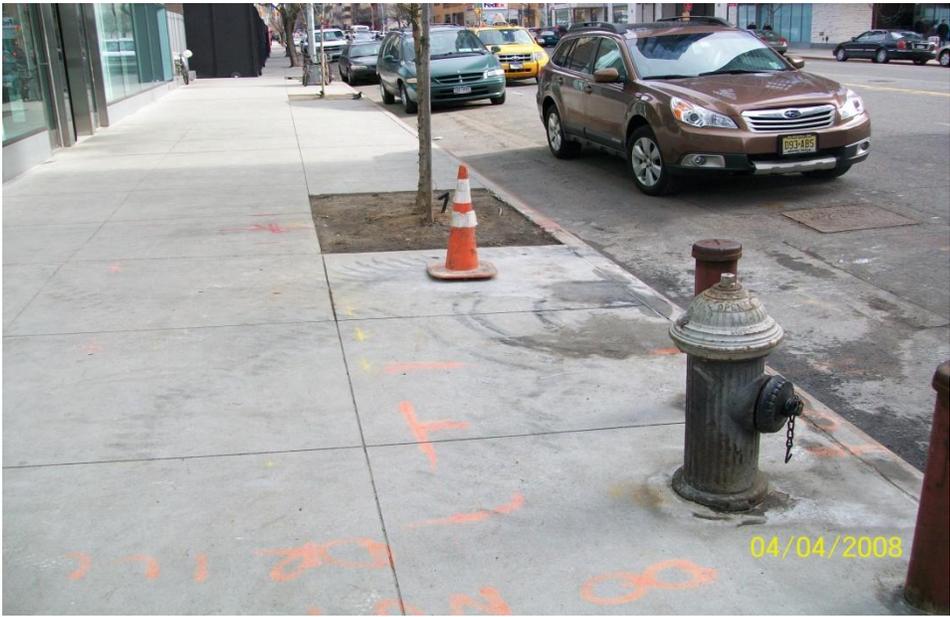
<b>CLIENT:</b> Con Edison	<b>SITE NAME:</b> West 42 <sup>nd</sup> Street Works
<b>PROJECT #:</b> B0043012	<b>SITE LOCATION:</b> 635 West 42 <sup>nd</sup> Street, Manhattan, New York
<b>PHOTOGRAPH #:</b> 1

<b>PHOTOGRAPHER:</b> THL	
<b>DATE:</b> 02/26/2011	
<b>DIRECTION:</b> East	
<b>COMMENT:</b> Proposed SB-50 location (indicated by cone) with nearby utility mark outs. Note that the date on the picture is incorrect.

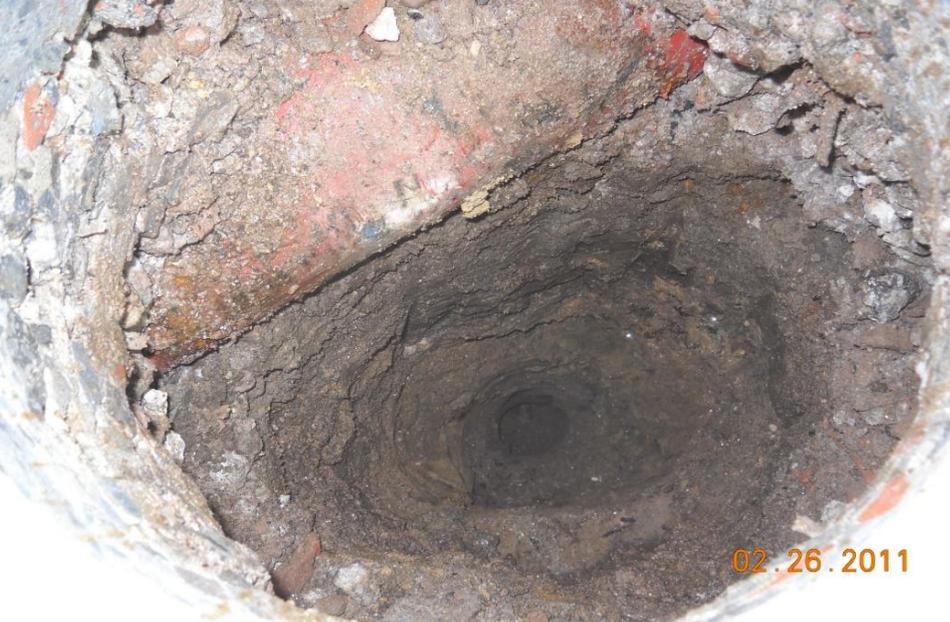
<b>PHOTOGRAPHER:</b> PP	
<b>DATE:</b> 02/26/2011	
<b>DIRECTION:</b> Northwest	
<b>COMMENT:</b> Completed 5 ft hand clear at SB-50, including red pipe encountered at approximately 18 inches below ground surface on the Northwestern side of the boring.

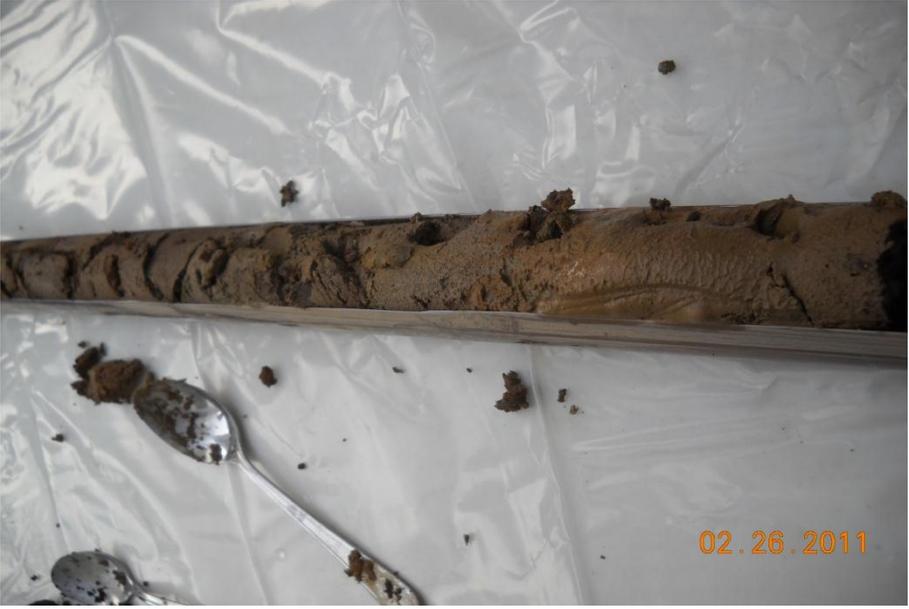
<b>PHOTOGRAPHER:</b> PP	
<b>DATE:</b> 02/26/2011	
<b>DIRECTION:</b> N/A	
<b>COMMENT:</b> Soils collected from 5 to 10 feet bgs (10 feet on the right). Note that a sample was collected at 9 feet. No visual impacts or PID hits were noted at any depth.

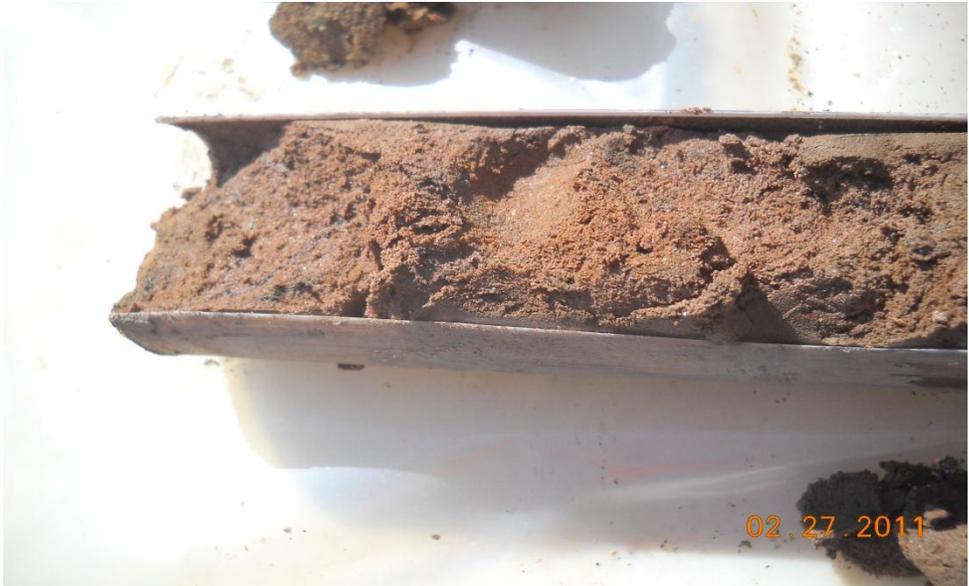
<b>PHOTOGRAPHER:</b> PP	
<b>DATE:</b> 02/27/2011	
<b>DIRECTION:</b> N/A	
<b>COMMENT:</b> View of soils collected from 10-15 ft bgs (15 ft on the left). Note that a soil sample was collected at 14.5 ft bgs.

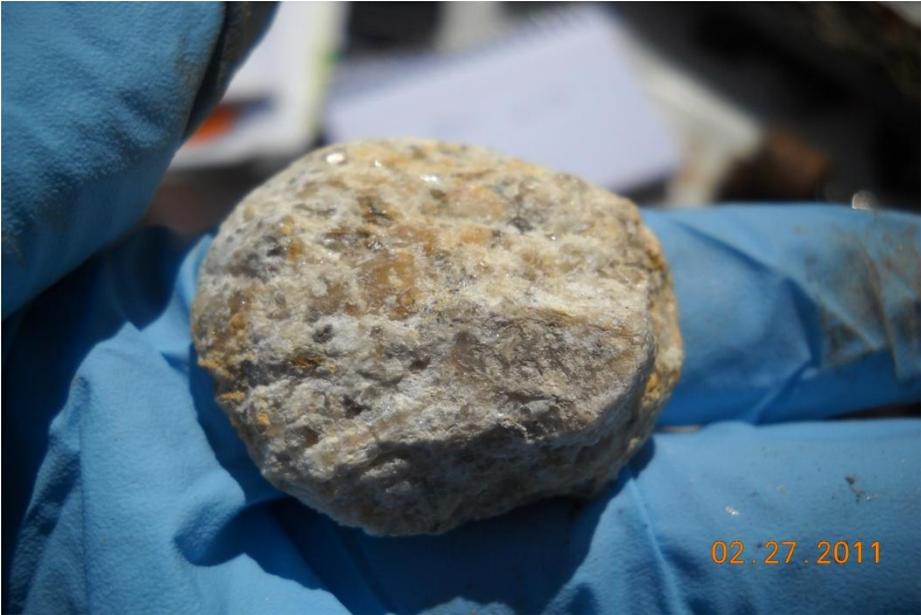
<b>PHOTOGRAPHER:</b> PP	
<b>DATE:</b> 02/27/2011	
<b>DIRECTION:</b> N/A	
<b>COMMENT:</b> Piece of bedrock encountered at 19.8 feet below ground surface.

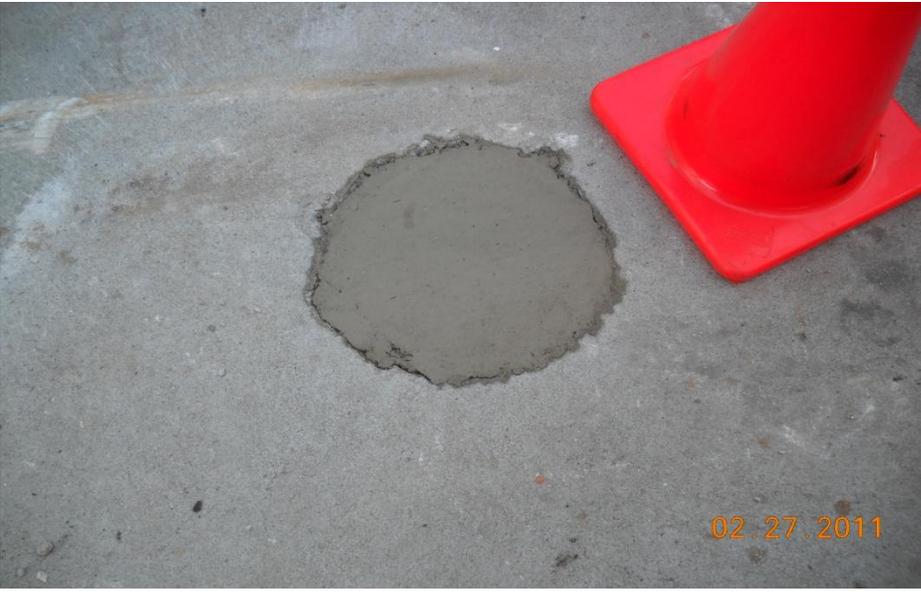
<b>CLIENT:</b> Con Edison	<b>SITE NAME:</b> West 42 <sup>nd</sup> Street Works
<b>PROJECT #:</b> B0043012	<b>SITE LOCATION:</b> 635 West 42 <sup>nd</sup> Street, Manhattan, New York
<b>PHOTOGRAPH #:</b> 4

<b>PHOTOGRAPHER:</b> PP	
<b>DATE:</b> 02/27/2011	
<b>DIRECTION:</b> South	
<b>COMMENT:</b> Completed surface restoration at SB-51.
