# REMEDIAL INVESTIGATION REPORT

Former West 42nd Street MGP  
VCA Number D2-003-02-08  
Site ID No. V00531

June 2016

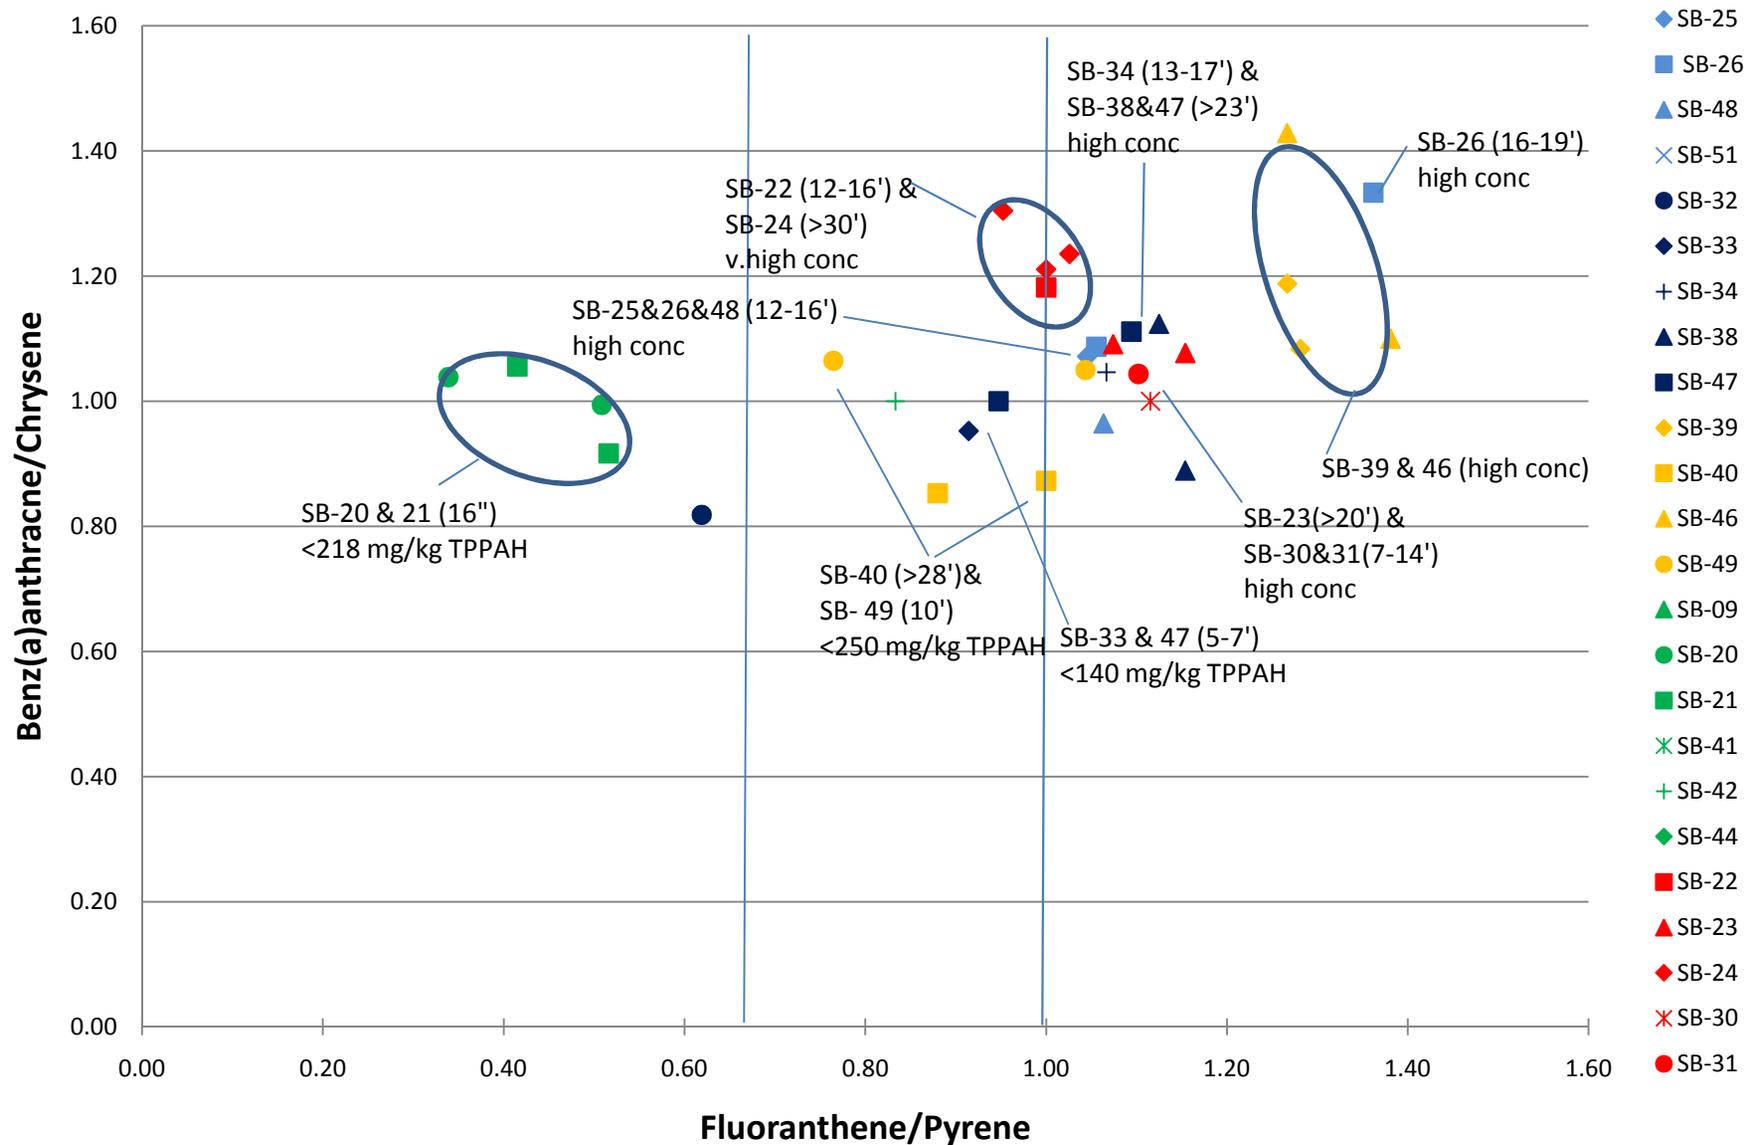
**Figure F-2 PAH Diagnostic Ratios--BAA/C v Fl/Py, Samples >10 mg/kg TPPAH  
W 42th St Former MGP Site**
